AVIATION INVESTIGATION REPORT

A05P0154

POWER LOSS

ROBINSON R22 BETA HELICOPTER C-FQDQ

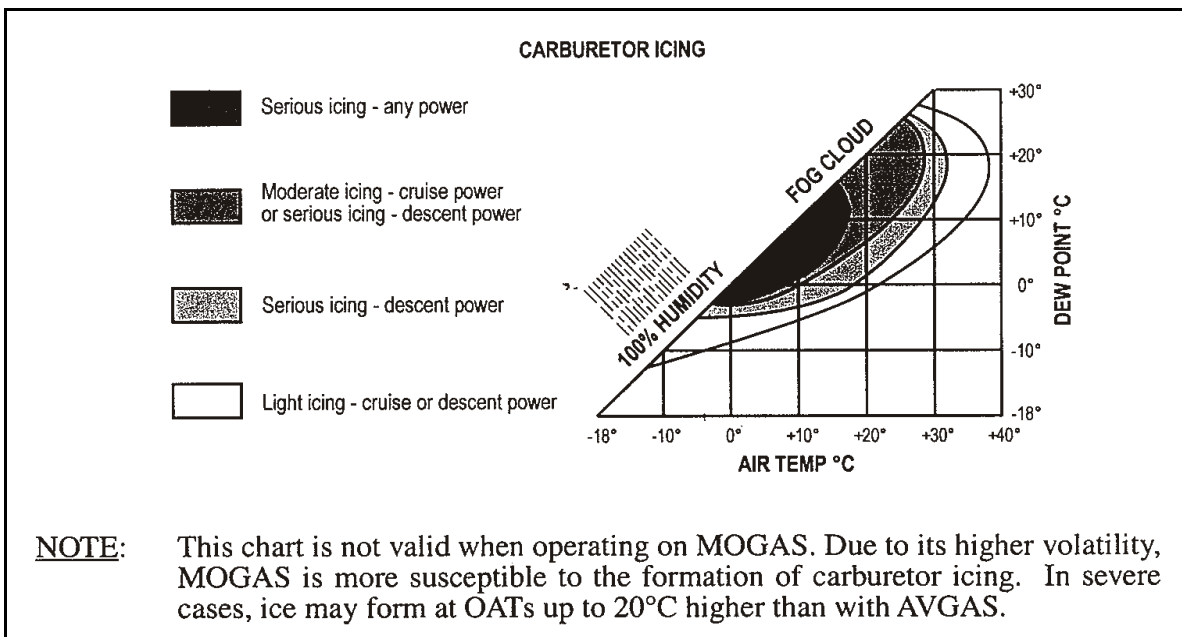
In most accidents involving carburetor icing, the pilot has not fully understood the carburetor heat system of the aircraft and what occurs when it is selected. Moreover, it is difficult to understand the countermeasures unless the process of ice formation in the carburetor is understood. Detailed descriptions of this process are available in most good aviation reference publications and any AME employed on type can readily explain the carburetor heat system. The latter is important because of differences in systems. The pilot must learn to accept a rough-running engine for a minute or so as the heat melts and loosens the ice which is then ingested into the engine. The following chart provides the range of temperature and relative humidity which could induce carburetor icing.

The weather conditions at the time of the occurrence were conducive to carburetor icing. However, if the pilot did not closely monitor the engine instruments, the formation of carburetor ice would initially be hidden while the governor was maintaining a constant manifold pressure and engine rpm. Therefore, whenever icing conditions are suspected, the pilot must apply carburetor heat as required. The pilot did not recall applying carburetor heat prior to departure or during take-off. There was nothing found to indicate that a mechanical
